SPARC Radiation Tolerant Processor Chip Set (CCA) Design Considerations List

This document describes the current identified specification deviations (as off October 26, 98) for the TSC691E (rev C), TSC692E (rev C) and TSC693E (rev A), with a work around proposal, when available.

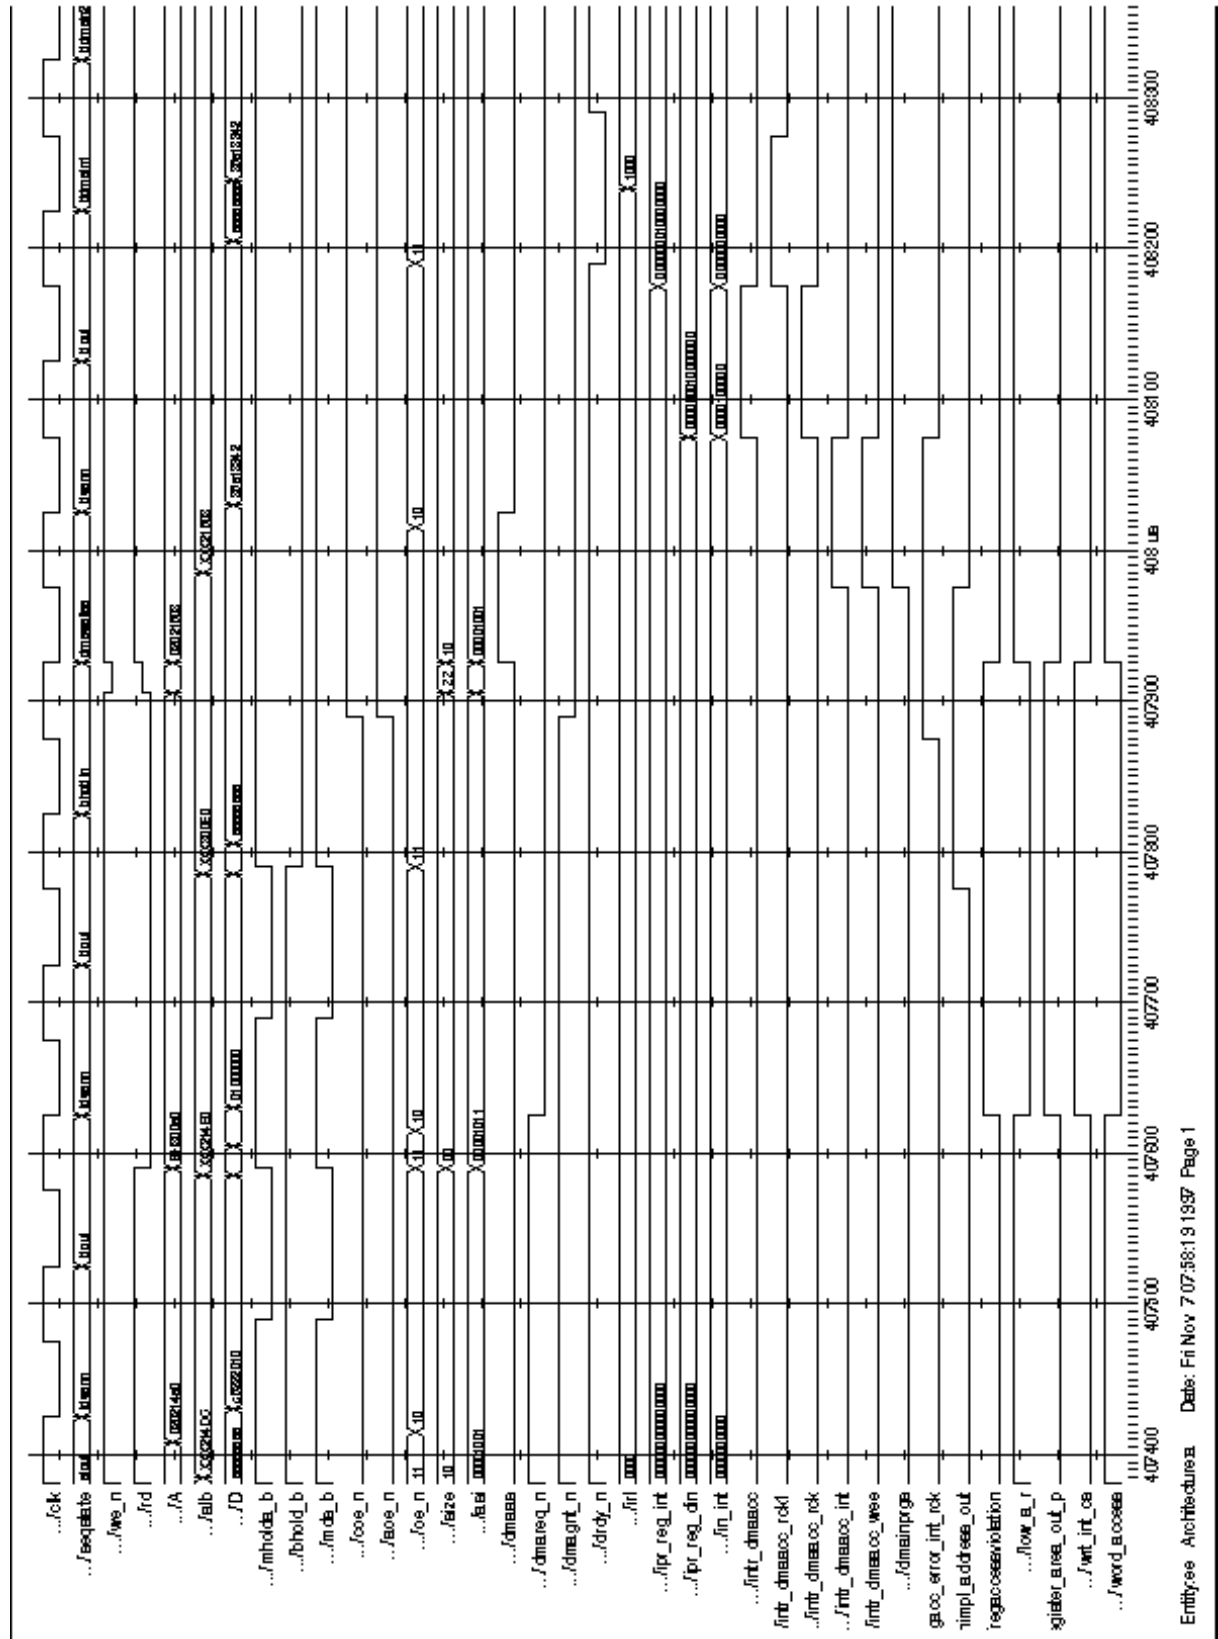
When a DMA access aborts an illegal store byte to a TSC693E register, the TSC693E register access violation leads to a DMA access error: IRL is set to 8.

stb %g0,[%g1 + 0xe0]

with [%g1 + 0xe0] addressing TSC693E UARTA register is aborted as shown on the following timing diagram.

The TSC693E did not record the context in which the register access violation occurred, that is an IU access, and propagated the error through the DMA access context, triggering a DMA access error.

No Workaround known.
